Field Experimental Study on Corrosion Mechanism of Well Lai 14-9

Abstract

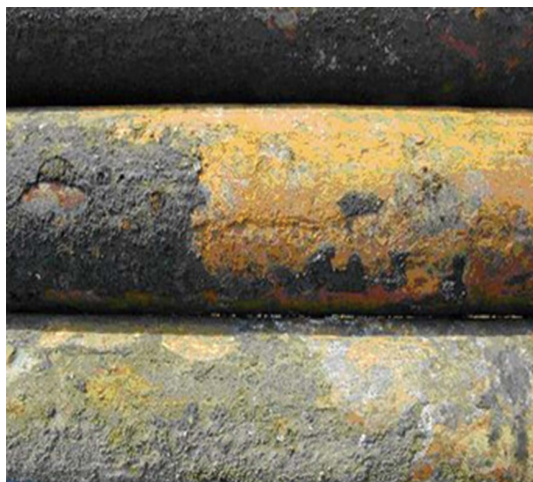
The conformation of casing corrosion is shown from Figure 1 to Figure 3. Casing corrosion has the following characteristics: (a) The corrosion fouling in outer layer of the casing wall is easy to fall off, its color is black and the thickness is 2-3 mm, and the inner layer of the casing wall is made up of rust material with different sizes, which indicates acute local corrosion (Figure 1); (b) There is even corrosion fouling covering the inner wall of the casing, its color is tawny and the thickness is 1-2 mm and

Figure 1
External Corrosion of Casing

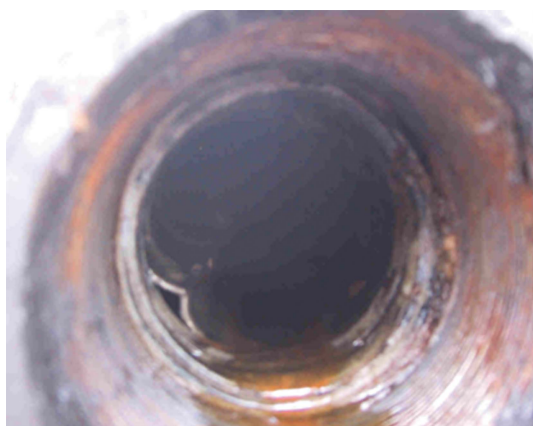
it is not likely to fall off, the inner wall is characterized by local potholes corrosion (Figure 2); (c) Some of the exterior surface of the casing is eroded by superficial water or even punched (Figure 3) and it can occur in just 8 months since its putting into production, which directly affected the normal operation of the oilfield and its safety.

Figure 2
Internal Corrosion of Casing

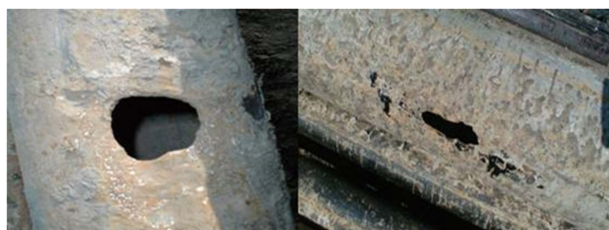
Figure 3
Casing Corrosion Punching

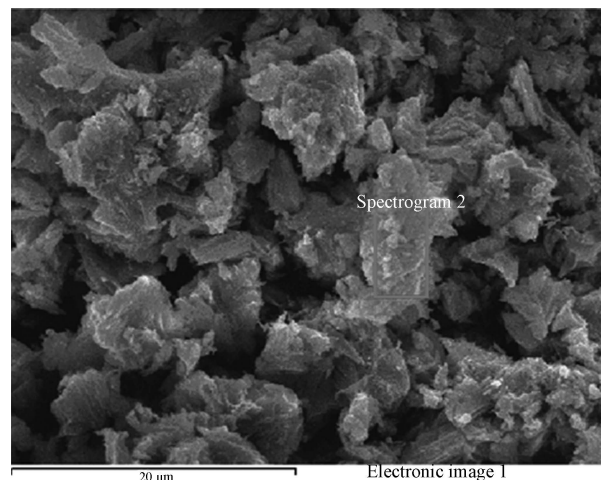
Figure 4
SEM Picture of Corrosion Fouling of 10 m Depth

It can be seen from Figure 4 that corrosion fouling is likely to fall off. SEM observation indicates that the product of corrosion mainly contains 3 elements: O, Fe and Cl. The reason for the casing corrosion of 10 m depth is thought to be the electrochemical erosion initiated by Cl^- , and its mechanism is shown as follows:

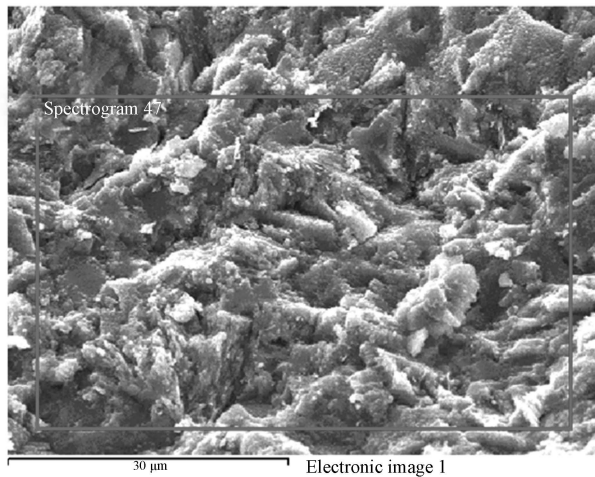
Figure 5
SEM Picture of Corrosion Fouling of 100 m Depth

The results show that the main element in the corrosion fouling is O and C, Fe and Cl followed. XRD analysis spectrum is adopted, and it can be analyzed that the corrosion products are mainly FeCO_3 , $\text{Fe}_2(\text{OH})_3$, $\text{Fe}_2\text{O}_3 \cdot n\text{H}_2\text{O}$, which is shown in Figure 6. So we can safely come to the conclusion that the main reason for the casing corrosion of 100 m depth is oxygen corrosion and carbon dioxide corrosion, and the existing of Cl increases the corrosion.

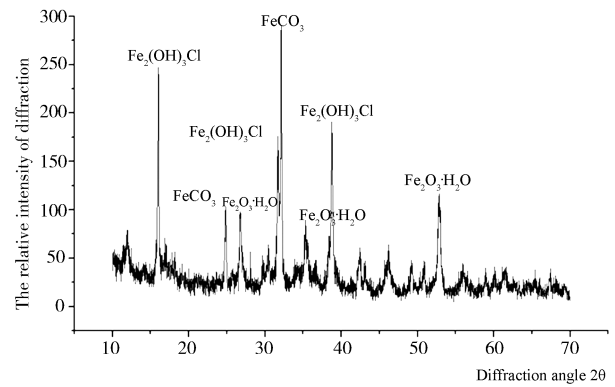
Figure 6
XRD Analysis Spectrum of the Corrosion Fouling Picture of 100 m Depth

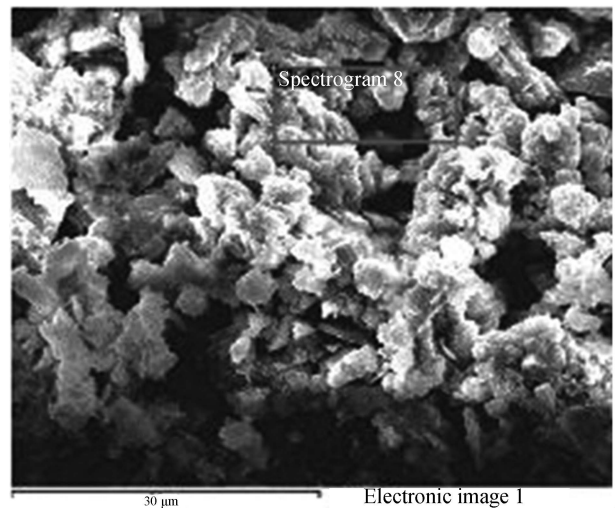
Figure 7
SEM Picture of Corrosion Fouling of 500 m Depth

The results show that the main element in the corrosion fouling is C and O, Fe and Ca follow. XRD analysis spectrum is adapted, and it can be analyzed that the corrosion product of 500 m depth are mainly Fe_9S_8 , CaCO_3 and FeCO_3 , which is shown in Figure 8.

So we can safely come to the conclusion that the main cause of the casing corrosion of 500 m depth is SRB, the reasons are as follows: (a) The temperature of 100 m to 1,000 m depth is about 30 to 40 Celsius degree, which falls in the limits that fits the build-up and reproduce of SRB; (b) The S elements of the Energy spectrum analysis are not from crude oil; (c) The Fe_9S_8 found in XRD analysis spectrum is one of the classic products of SRB corrosion.

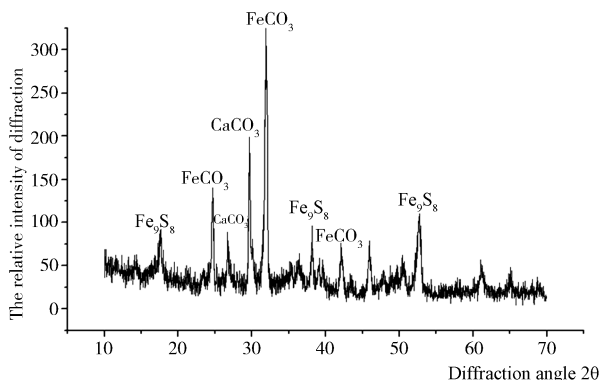
**Figure 8**
XRD Analysis Spectrum of the Corrosion Fouling Picture of 500 m Depth

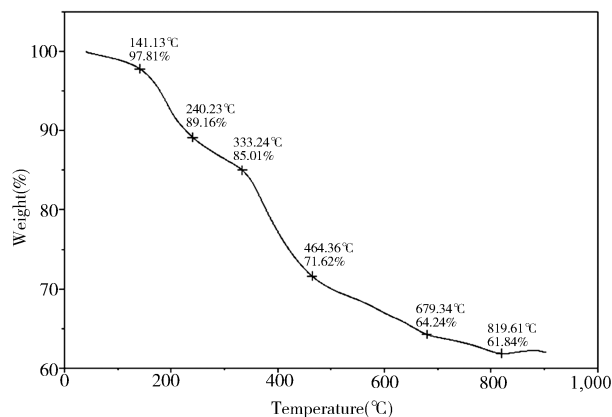
**Figure 9**
TGA Analysis of the Corrosion Fouling Picture of 500 m Depth

After analyzing of TGA analysis results, it can be easily seen that there are two temperature weightless intervals: 141.3 - 240.23 °C and 333.24 - 464.36 °C. They respectively correspond to the hydrate decomposition and the decomposition of FeCO_3 . Besides, there are some twists and turns in the curve which indicates various compounds in the sample.

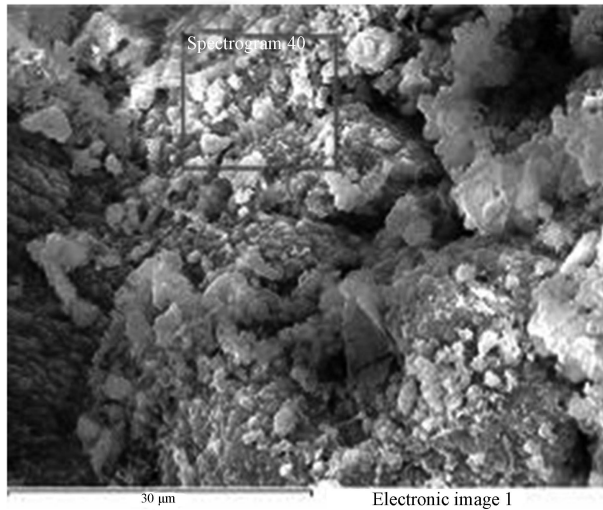
The corrosion fouling of 1,600 m depth from the ectoecium of oil tube of well Lai 14-9 is collected and analyzed with SEM observation and Energy spectrum analysis and the results are shown in Figure 10 and Table 4. From Table 4 we can see that the main elements in the corrosion fouling are still C, O and Fe. The result of XRD analysis spectrum shows that the corrosion product is mainly (Ca, Mn) CO_3 (Figure 11), it also indicates serious scale deposit in this injecting well. The existence of CO_3^{2-} indicates that CO_2 corrosion is the main reason for the casing corrosion in this layer.

Figure 10
SEM Picture of Corrosion Fouling of 1,500 m Depth

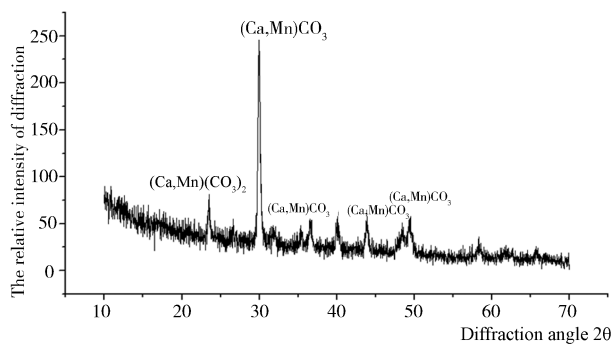
Figure 11
XRD Analysis Spectrum of the Corrosion Fouling Picture of 1,500 m Depth

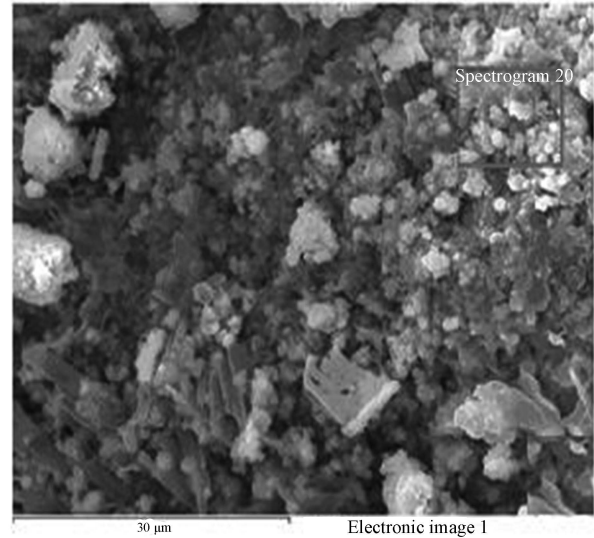
Figure 12
SEM Picture of Corrosion Fouling of 2,100 m Depth

The results show that the main elements in the corrosion fouling are orderly C, O, Fe, S and Cl. Of all of them, C and O are much more, which indicates the corrosion product is mainly carbonate. XRD analysis spectrum and TGA analysis are practiced on the corrosion fouling and the results are shown in Figures 13 and 14. The results show that the corrosion product is mainly FeCO_3 . It also shows that casing corrosion in this layer is mainly resulting from CO_2 corrosion.

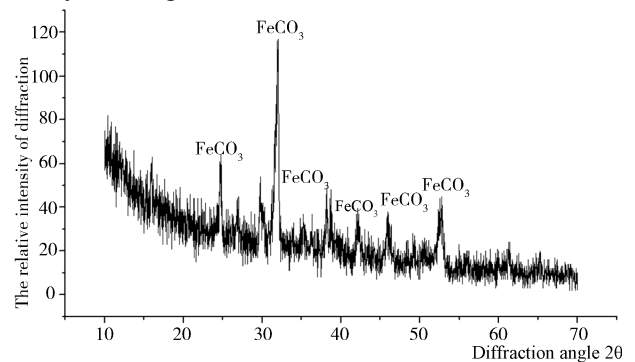
Figure 13
XRD Analysis Spectrum of the Corrosion Fouling Picture of 2,100 m Depth

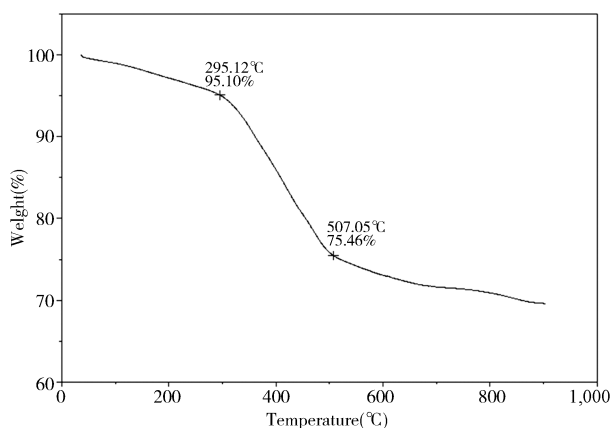
Figure 14
TGA Analysis the Corrosion Fouling Picture of 2,100 m Depth
